Surface Cable Connector Issues from the 2004-05 Pole Season

John Kelley and Johan Lundberg
January 16, 2005

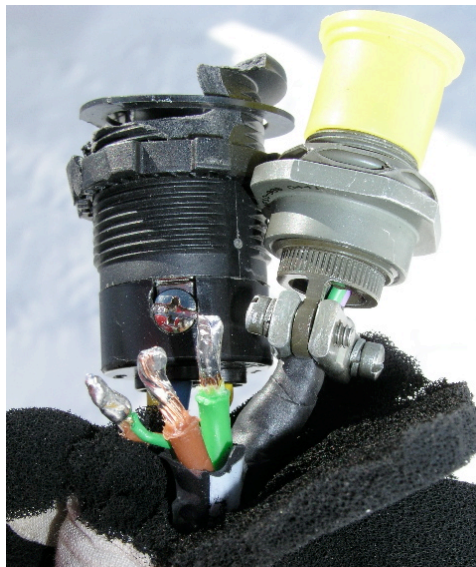
Upon inspecting the JDR surface cable after it was deployed in the trench, we immediately found issues with the Marincos IceTop tank power connectors, RIP1A and RIP2A. RIP1A was seriously damaged, and RIP2A was completely missing, with the bare wires exposed. We are not sure if this happened during cable deployment, in shipping, or at some prior point, but clearly the cable was mishandled or mispackaged at some point.

Figure 1: Broken and Missing Marincos Connectors on JDR Cable

We replaced both connectors with spares from the IceTop Smurf setup.

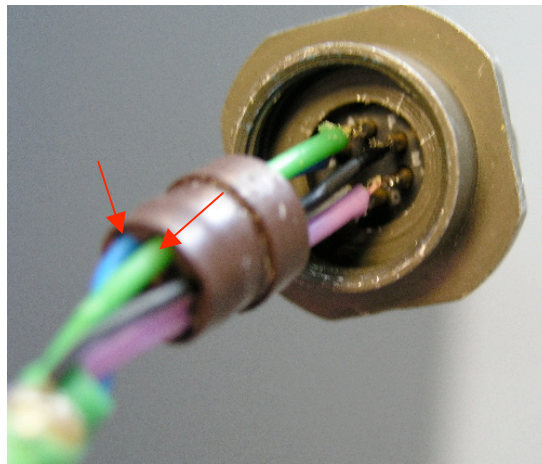
While checking the communications on the JDR cable through IceTop quad IQ1, we found that the connector was miswired on both ends. Electrically, the correct pins were connected, but the wrong pairs in the quad were used, increasing crosstalk and causing communications to fail. Both connectors were rewired to correct the problem.

Figure 2: Miswired IQ1 connector — blue and green wires should be used with A/D pair, not A/B (JDR cable)

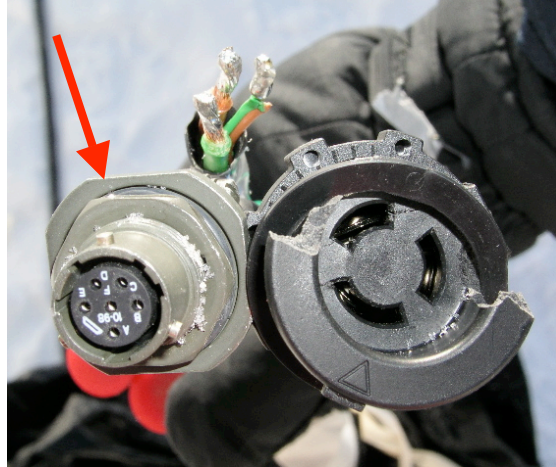
The surface junction box (SJB) end of IQ3 should have a female, cable-end MS connector with pentagonal+1 pin pattern. Instead, the JDR cable had a female, *panel-end* MS connector with pentagonal+1 pin pattern.

Figure 3: Wrong Connector on IQ3, JDR Cable, SJB End

We corrected the connector at the SJB, and we made a custom cable for the TCH with a mating connector.

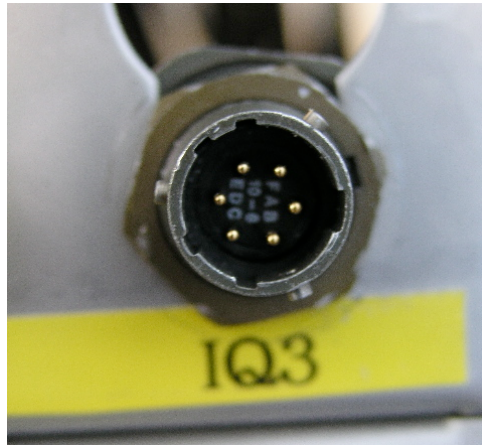
The TCH end of IQ3 should have a female, panel-end MS connector with pentagonal+1 pin pattern. Instead, the JDR cable had a *male*, panel-end MS connector with *hexagonal* pin pattern.

Figure 4: Wrong Connector on IQ3, JDR Cable, TCH End

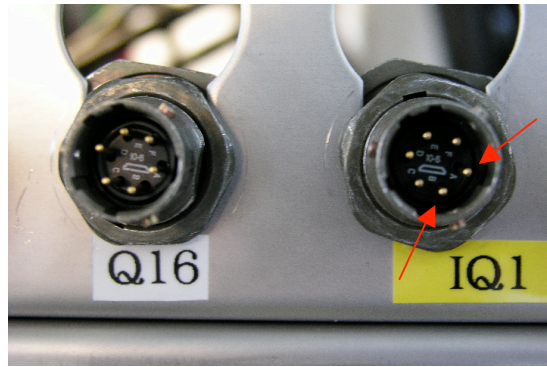
Upon unwrapping the MS connectors of the surface cable at the TCH and placing them in the patch panel, we noticed that a significant fraction (at least 10%) of the connectors had visibly bent pins. The pins are not so badly bent that they can't be straightened; however, this makes connections much trickier, and if the same situation occurs at the SJB, the detail work required outside could be quite difficult. Even inside, one patch cable connection took 1/2 hour, because the pins were bent in a symmetric way that was difficult to detect.

With the Ericsson cables, it was clear that this was the first time the connectors had been unwrapped since delivery, indicating that the pins were bent at some point prior to shipment.

Figure 5a: Example of Connector with Bent Pins (Ericsson Cable)

- Better quality control after production, including checking the gender and pins of all connectors
- Sturdier packaging of connectors during transport, and/or more careful handling during deployment
- Shipping spare connector kits of all genders and pin configurations to the pole for use in fixing any of these problems that occur in the future

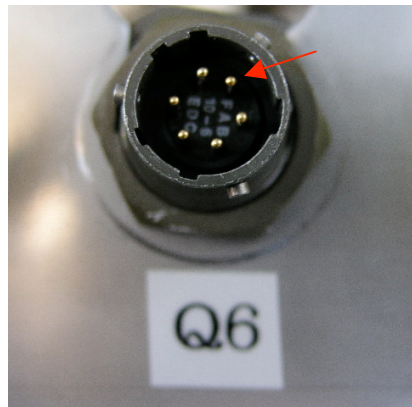
Figure 5b: Example of Connector with Bent Pins (Ericsson Cable)

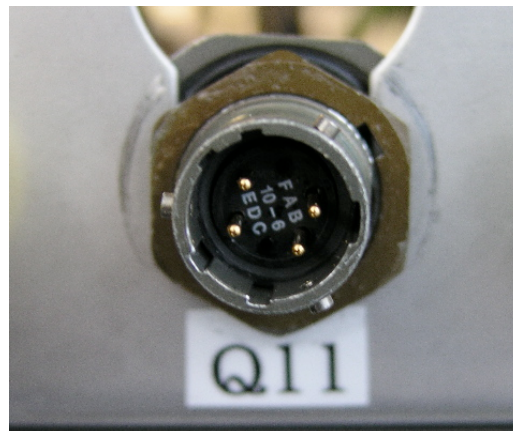
Additionally, we found one MS connector on the JDR cable at the TCH end that had two missing pins. Luckily, the missing pins of the 6-pin connector are the two that aren't used.

Figure 6: Connector with Missing Pins (Ericsson Cable)
